Public Meeting on Permitting and Cleanup Activities at Alcoa Badin Works

Wednesday November 16, 2022 Atrium Health Meeting Room

Presentation by Ryke Longest, Duke Environmental Law & Policy Clinic

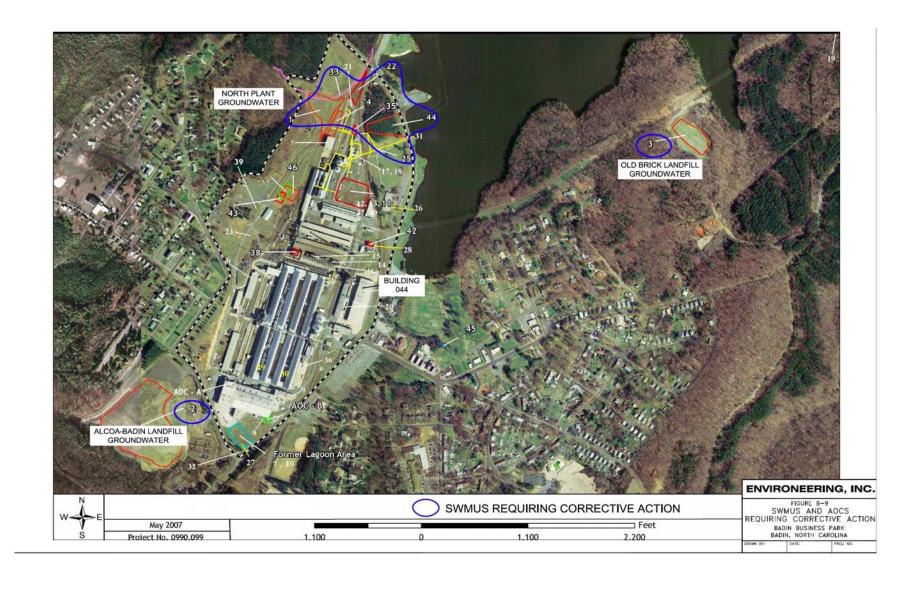
Solid Waste Management Unit (SWMUs) Requiring Corrective Action

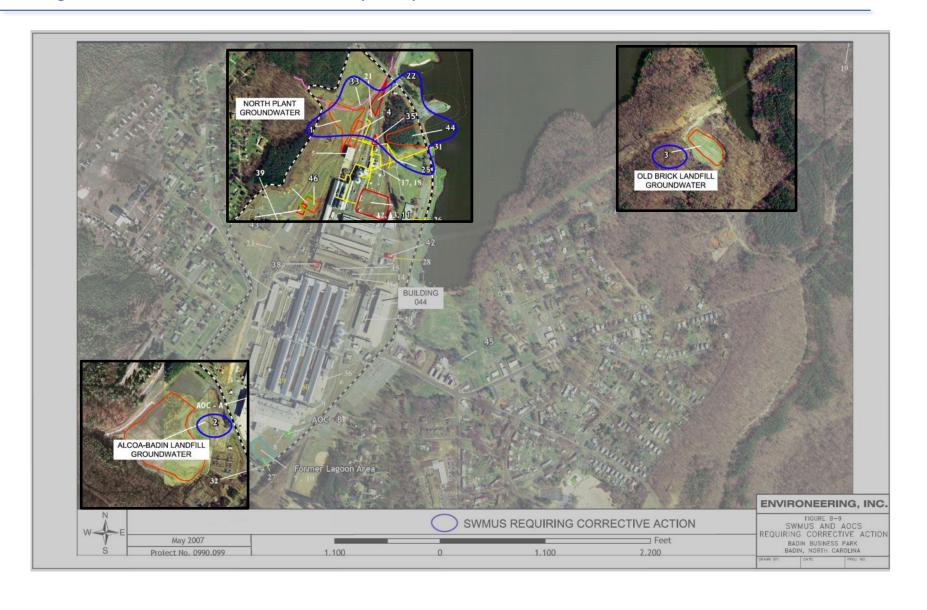
Largest SWMU areas with buried spent potliner

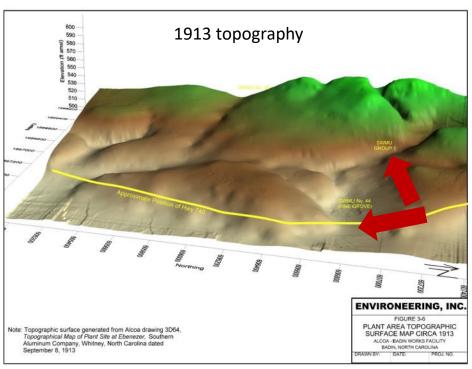
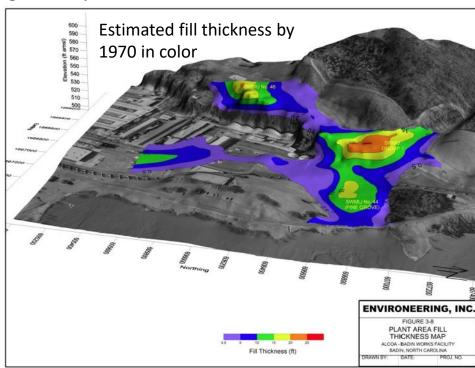
Topography (shape of the land)

North End SWMU Area is a natural valley that was progressively filled in from 1916 to 1968

Red arrows point to sites where spent potliner was dumped in a valley draining into Badin Lake, from 1910s to 1970s

By 1970s, cyanide and fluoride were leaching from **unlined** fill material (in color) into surface water and Badin Lake.

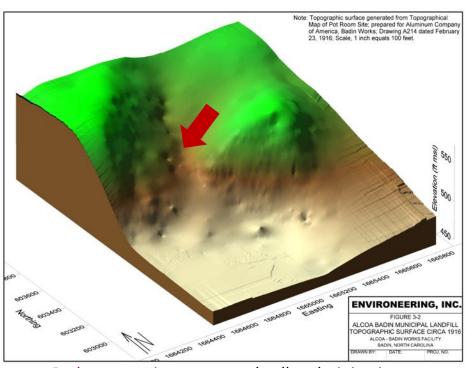
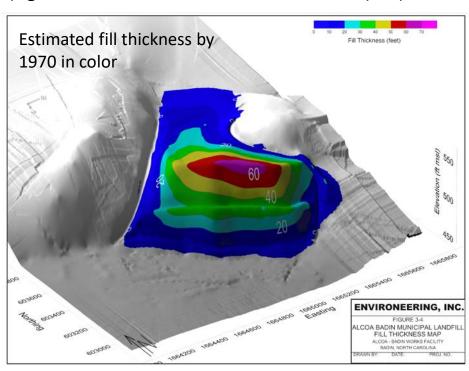
SMWU No. 2: Alcoa-Badin Landfill topography

SWMU No. 2 was a natural valley used as a dump (right), graded between mid-1970s and 1990s (left)

Red arrow points to natural valley draining into Little Mountain Creek
